# **Q** INSTALLATION RESTORATION PROGRAM

PHASE I - RECORDS SEARCH

4TRAVIS AFB, \*CALIFORNIA

**AUGUST 1983**

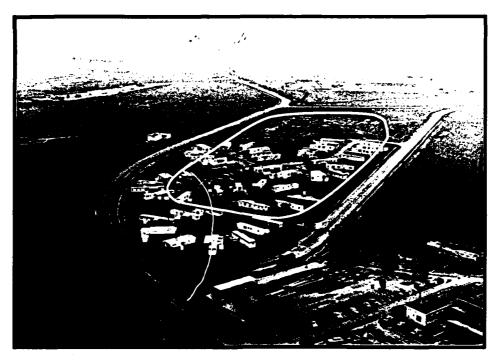
at least several times per week. The landfill received primarily general refuse; however, some industrial wastes likely entered the landfill. Burning operations likely reduced any long term hazards associated with any disposal of solvents or oils. The area directly west of the landfill was reported to have been used for the disposal of hardfill materials. Landfill No. 1 was closed during the mid 1950's. The area was covered and compacted and now supports a trailer park community. Landfill No. 2

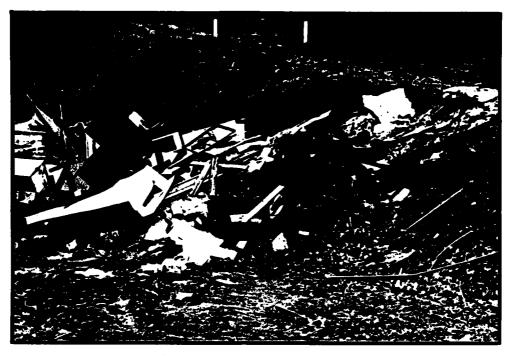
Point Arena Disposal Site No. 1 Burn Area
